AVR-A-1-S1-C-P

SYSTEM DESCRIPTION AND REPAIR PROCEDURE

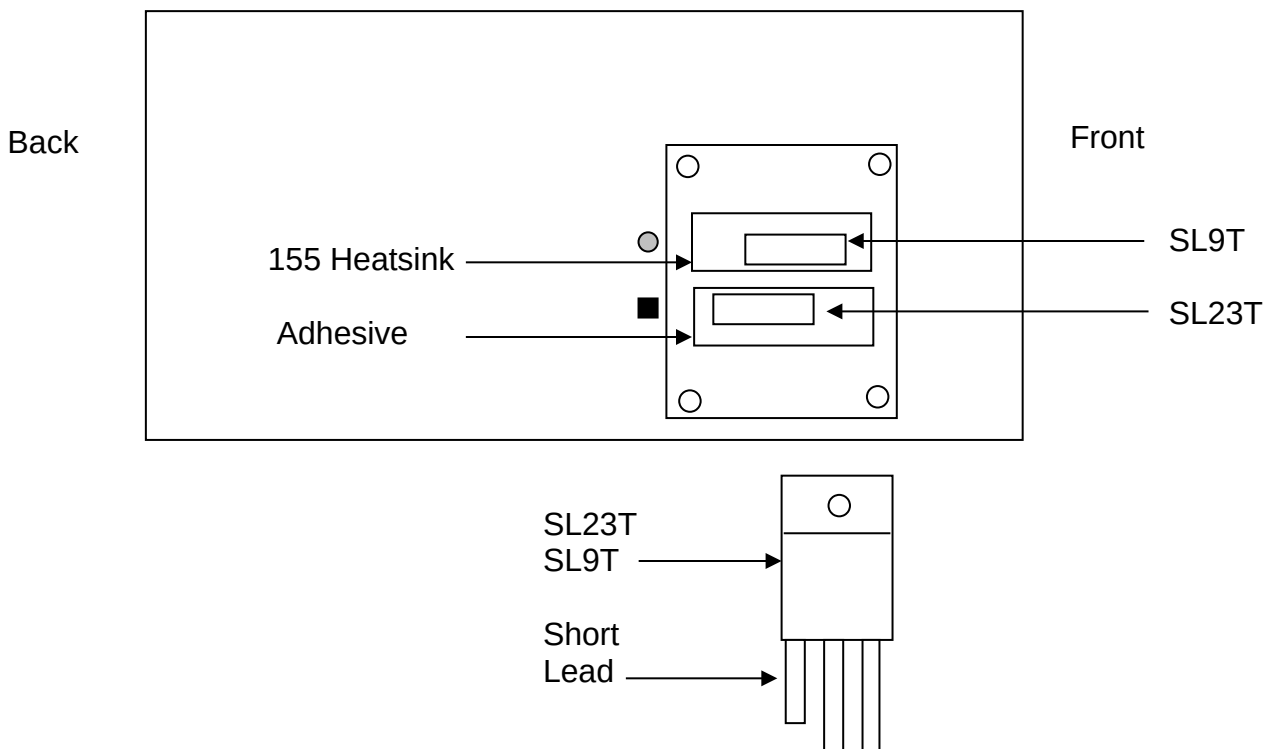
Bottom View of Chassis

If the unit still does not function, it is most likely that some of the output switching elements (SL9T and SL23T) may have failed due to an output short circuit condition or to a high duty cycle condition. The switching elements may be accessed by removing the cover plate on the bottom side of the chassis. The cover plate is removed by removing the two 2-56 Phillips screws.

The elements may be removed from their sockets by means of a needle nosed pliers after removing the four counter sunk 2-56 Phillips screws which attach the small copper heat sink to the body of the output module. The SL9T and SL23T are selected Mosfet power transistor in a TO-220 package and may be checked on a curve tracer. If defective, replacement units should be ordered directly from Avtech. When replacing the SL switching elements, take care to ensure that the short lead (of the three leads) is adjacent to the black dots towards the back of the chassis. (See the following illustration). The SL elements are electrically isolated from the small copper heat sink but are bonded to the heat sink using Wakefield Type 155 Heat Sink Adhesive.
