LVA REPLACEMENT INSTRUCTIONS

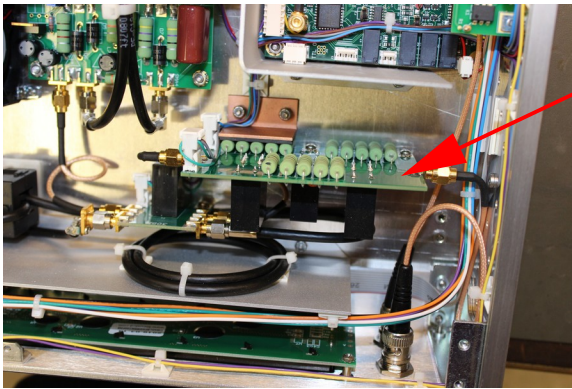
1. Disconnect the power cord from the rear panel.
2. Let the instrument sit unpowered for at least one minute, to allow any stored charge to dissipate.
3. Remove the 4 screws that secure the top cover. Slide the cover off (towards the rear).
4. Locate the existing LVA assembly, shown below:

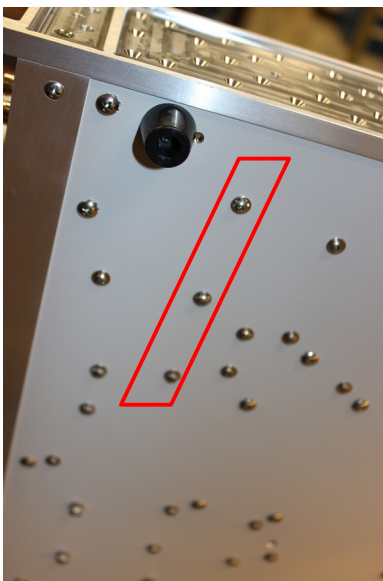
5. Remove (and save) the 3 screws (and associated washers) that attach the assembly to the bottom cover:

8. Remove the LVA assembly from the instrument.
9. Re-install the white wire harness headers.
10. Re-install the two SMA cables.
11. Re-install the three screws on the bottom cover. Adjust the assembly so that the 5 green resistors rest against the adhesive heatsink pad.
12. Re-install the top cover.
13. Re-install the power cord.
14. Test the basic operation of the instrument at +0.4, +4, +40, and +400V.

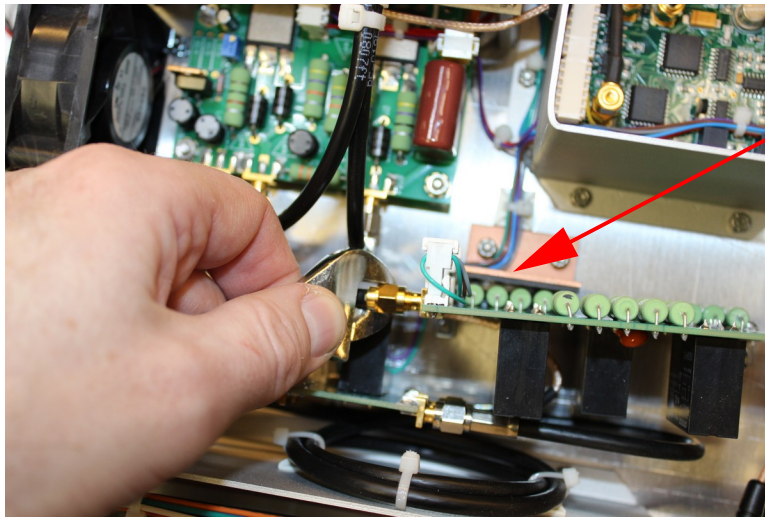
Adhesive
heatsink

6. Gently pull the assembly away from the adhesive heatsink pad mounted on a copper bracket. Unscrew the 2 SMA cables connected to the LVA assembly:

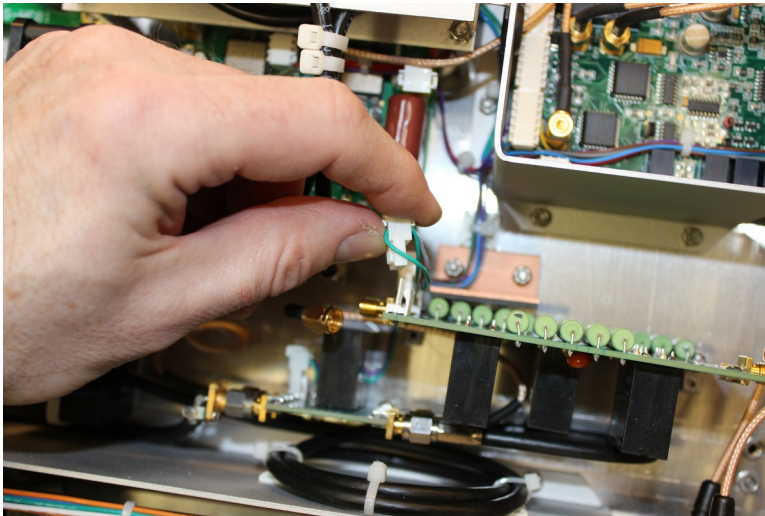
7. Gently pull off the 2 white wire harness headers:
