AVO-2-C-BEO3-R5-P-OP1-M
Instruction Manual Addendum

For serial numbers 8879 - 9430

POWER SUPPLY AND FUSE REPLACEMENT

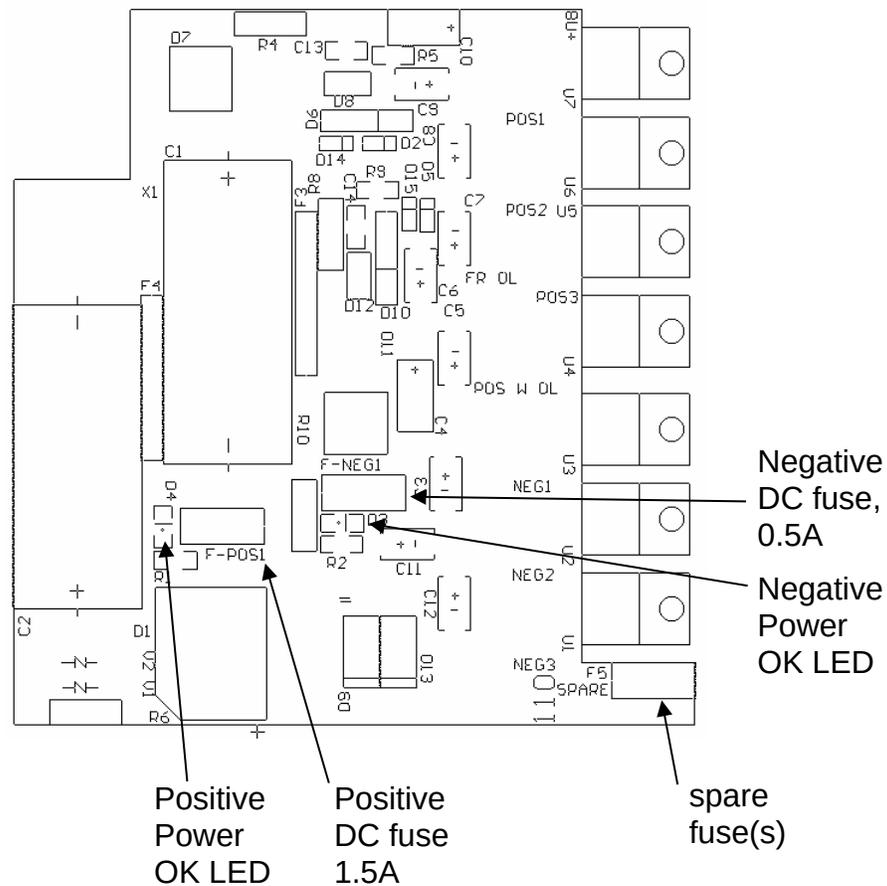
The other two fuses (plus spares) are located on the internal DC power supply, as shown below:

The positive fuse and the one of the spare fuses on this circuit board are 1.5A slow-blow fuses, Littelfuse part number R45201.5. (This fuse can be ordered from Digikey, www.digikey.com. The Digikey part number is F1344CT-ND).

Instruments with serial numbers between 8879 and 9430 (inclusive) were originally shipped with 1A fuses, instead of 1.5A fuses. The 1A fuses should be replaced with the 1.5A fuses supplied with this addendum.

The negative fuse is a 0.5A slow-blow fuse (Littlefuse R452.500, Digikey part number F1341CT-ND). If a second spare fuse is present, it should also be 0.5A.

1. Remove the top cover, by removing the four Phillips screws on the top cover and then sliding the cover back and off.
2. Locate the two "Power OK" LEDs on the power supply circuit board, as illustrated above.
3. Turn on the instrument.
4. Observe the "Power OK" LEDs. If the fuses are not blown, the two LEDs will be lit (bright red). If one of the LEDs is not lit, the fuse next to it has blown.
5. Turn off the instrument.
6. If a fuse is blown, use needle-nose pliers to remove the blown fuse from its surface-mount holder.
7. Replace the fuse.
